6.0 Grand Junction, Colorado, Disposal Site

The Grand Junction, Colorado, Disposal Site, inspected on April 4, 2007, is in good condition. A portion of the disposal cell remains open and is operated by DOE to receive additional low-level radioactive waste materials from various sources. The annual inspection requirement is only applicable to the closed and completed portion of the disposal cell and surrounding disposal site.

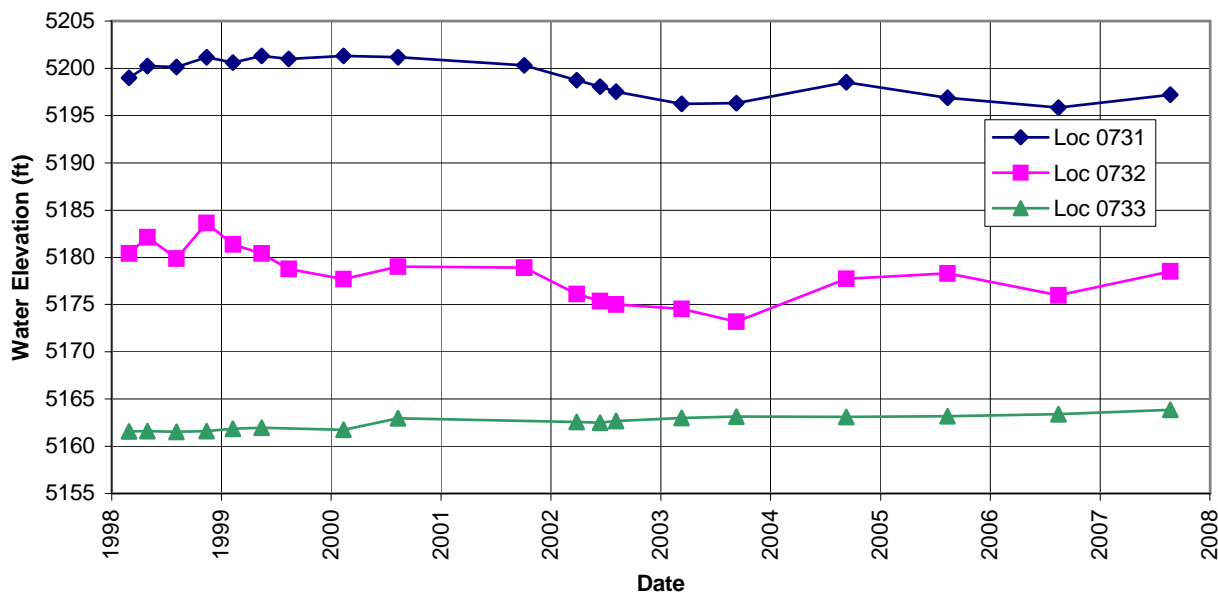
Figure 6-2. Water Level Measurements at the Grand Junction, Colorado, Disposal Site

The water level in the disposal cell well MW-0733 has displayed a steady continual rise, although relatively minor; approximately 2 feet of increase since 1998. This continued through the 2007 monitoring, with an increase of approximately 0.5ft. The water level in the disposal cell well MW-0733 has remained significantly deeper than water levels in the paleochannels at wells MW-0731 and MW-0732, respectively, since 1998 (Figure 6-2).

Water levels within the two paleochannels at wells MW-0731 and MW-0732 have displayed a decrease, although more varied and larger; approximately 4 to 5 feet of decrease since 1998. In 2007 these two wells showed slight increases, but still are below initial levels in 1998.

On the basis of this information, there is no hydraulic potential for groundwater at the base of the disposal cell at well MW-0733 to migrate to the paleochannels at wells MW-0731 and MW-0732.

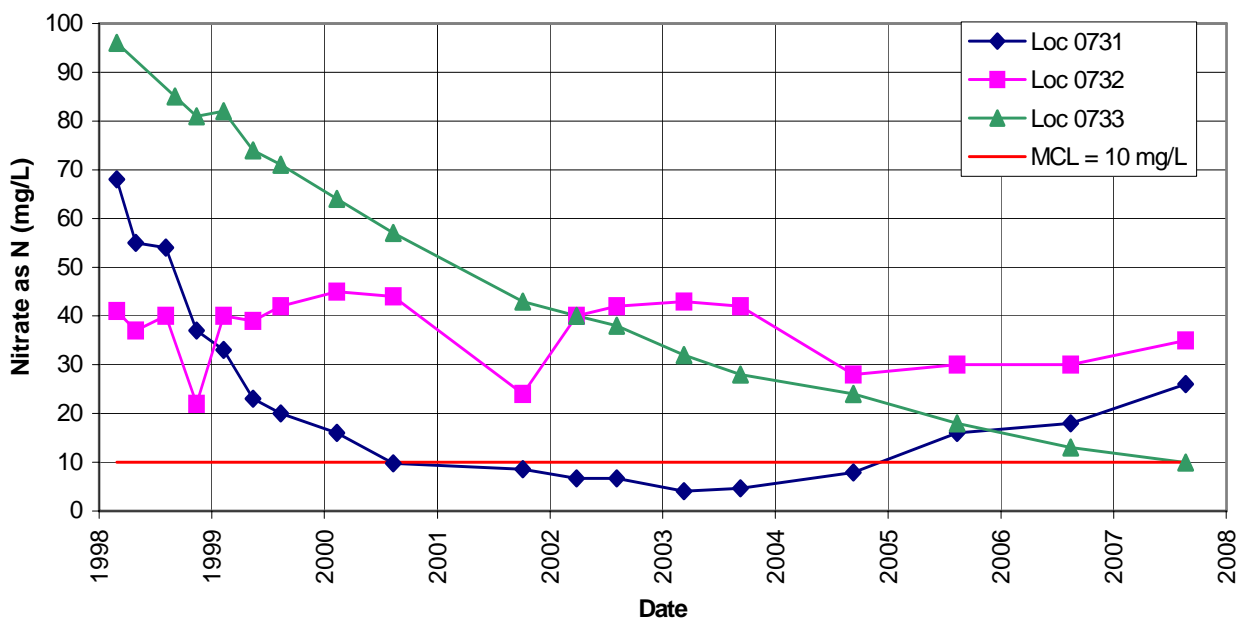
Figure 6–3. Time-Concentration Plots of Nitrate (as N) in Groundwater at the Grand Junction, Colorado, Disposal Site

Nitrate (as nitrogen) concentrations in groundwater continue to exceed the MCL of 10 mg/L in the paleochannel monitor wells (MW-0731 and MW0732) through 2007 (Figure 6–3). Concentrations in well MW–0731, following an initial steep downward trend, remained below the MCL from 2000 through 2004. In 2005, and continuing through 2007, concentrations were above the MCL. Concentrations in well MW–0732, although varied, have consistently remained above the MCL since 1998. Concentrations in well MW–0733 continue a significant downward trend, just slightly above the MCL in 2006, and reaching an historical low of 9.9 mg/l in 2007. Historically, the highest concentration of nitrate (96 mg/L) occurred in 1998 from the disposal cell well MW–0733. In 2007, the highest concentration of nitrate, 35 mg/L, occurred in paleochannel well MW–0732.

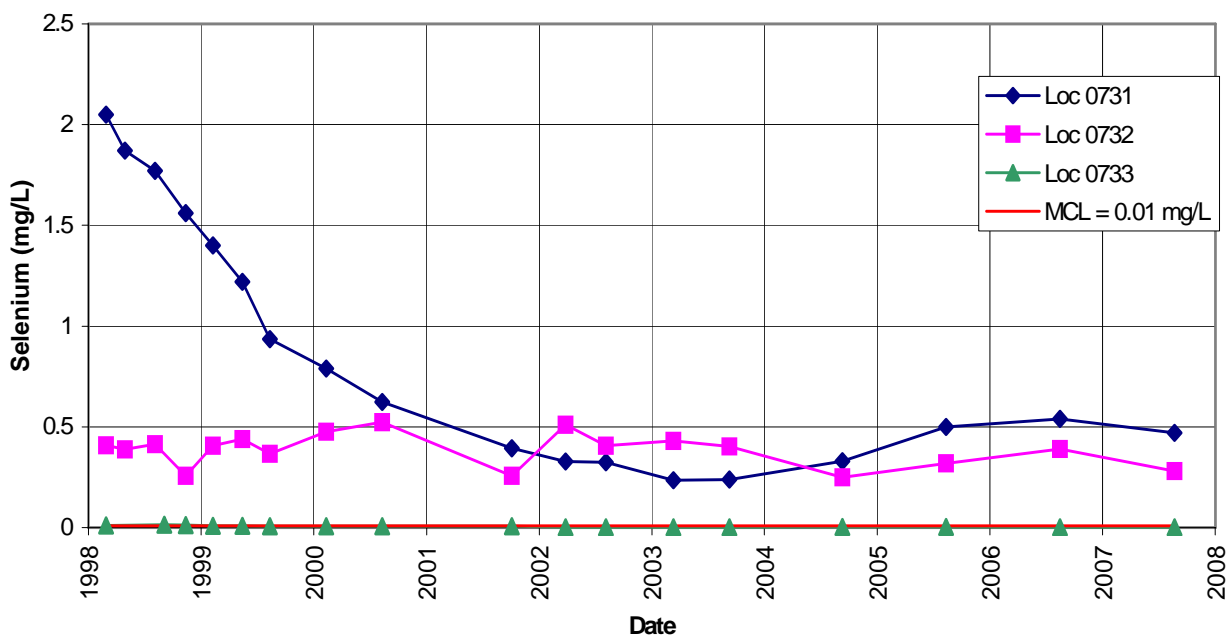
Figure 6-4. Time-Concentration Plots of Selenium in Groundwater at the Grand Junction, Colorado, Disposal Site

Selenium occurs naturally in the Mancos shale deposits that underlie the disposal cell and may be the cause of the elevated concentrations reported in both paleochannel monitor wells MW–0731 and MW–0732. Selenium concentrations continued to exceed the MCL of 0.01 mg/L in

wells MW-0731 and MW-0732 (Figure 6-4). Concentrations in well MW-0731 displayed a sharp decreasing trend, with the decreasing trend continuing until 2003, at which time a slight upward trend began. In 2007 concentrations in both wells decreased approximately 0.1 mg/L. The selenium concentration (0.0025 mg/L) remained well below the standard in well MW-0733. The concentrations in this well have remained remarkably stable since 2001. In 2007, the highest concentration of selenium, 0.47 mg/L, occurred in paleochannel well MW-0731.

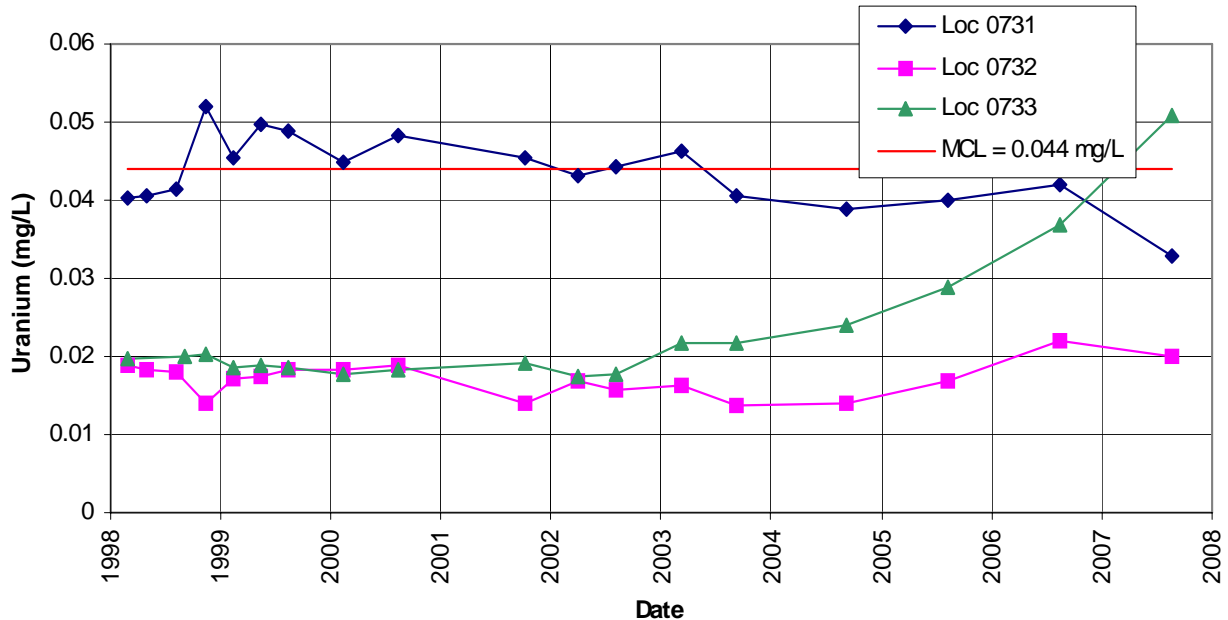
Figure 6–5. Time-Concentration Plots of Uranium in Groundwater at the Grand Junction, Colorado, Disposal Site

Uranium concentrations in groundwater were below the MCL of 0.044 mg/L in samples from the two paleochannel wells MW-0731 and MW-0732, but were reported above the MCL in well MW-0733 (0.051 mg/L) for the first time (Figure 6-5). Concentrations in well MW-0731, after an initial increase, have displayed a decreasing trend that continued in 2007. Concentrations in wells MW-0732 and MW-0733 remained relatively consistent through 2003, at which time an upward trend began in both wells; although, in 2007, the concentrations in well MW-0732 decreased slightly.

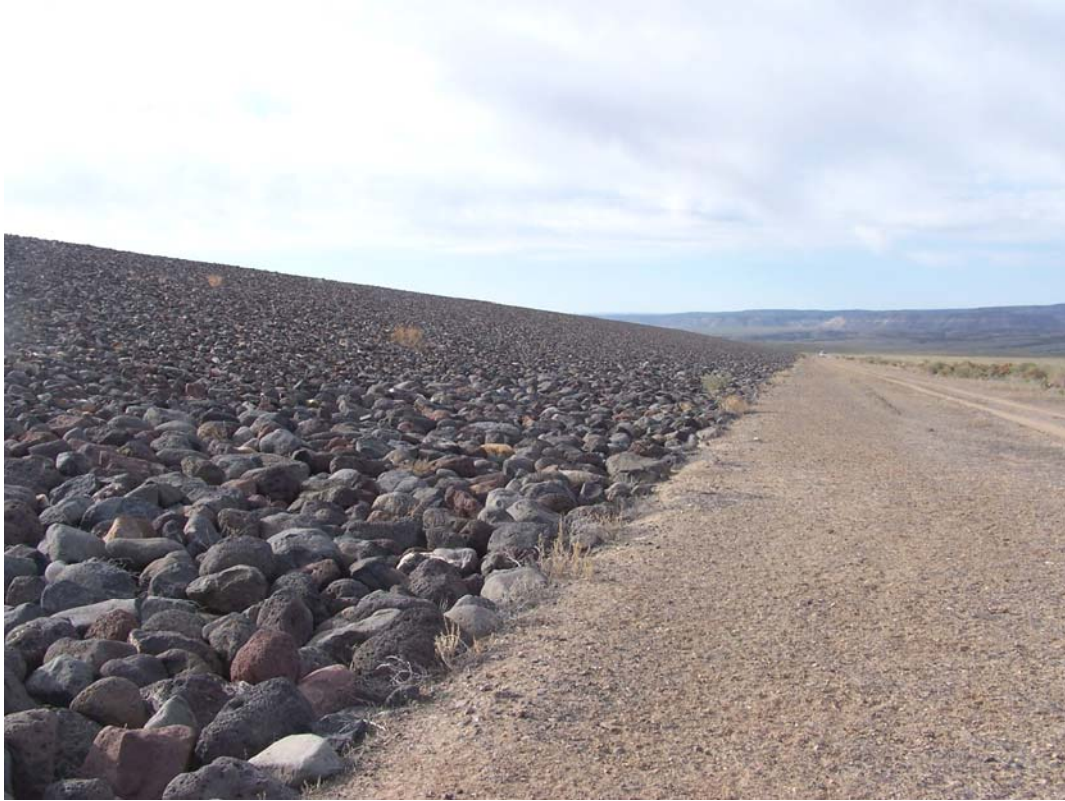
Closed Portion of the Disposal Cell—The top and side slopes of the disposal cell are covered with basalt riprap. The rock is durable and in excellent condition. There is no evidence of slope instability and very little plant encroachment is occurring on the side slopes (PL-1 and PL-2).

GRJ 4/2007. PL-1. View south along the west side slope and apron.

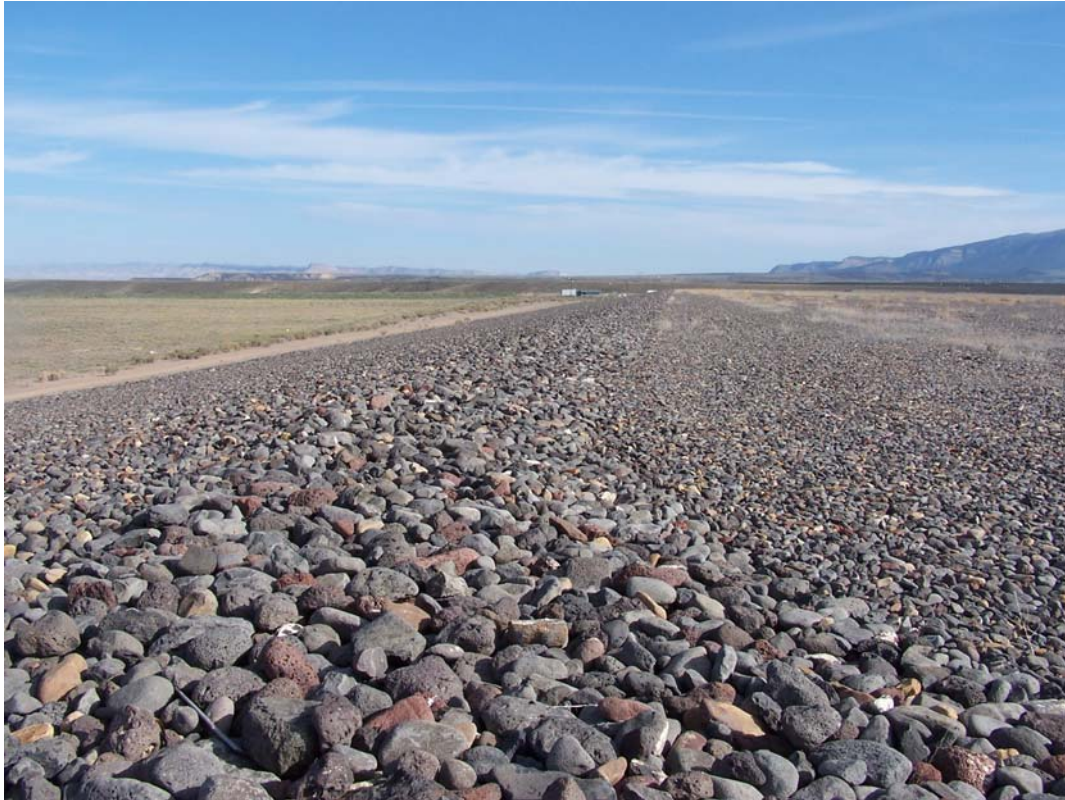
GRJ 4/2007. PL-2. View north along the west side slope.

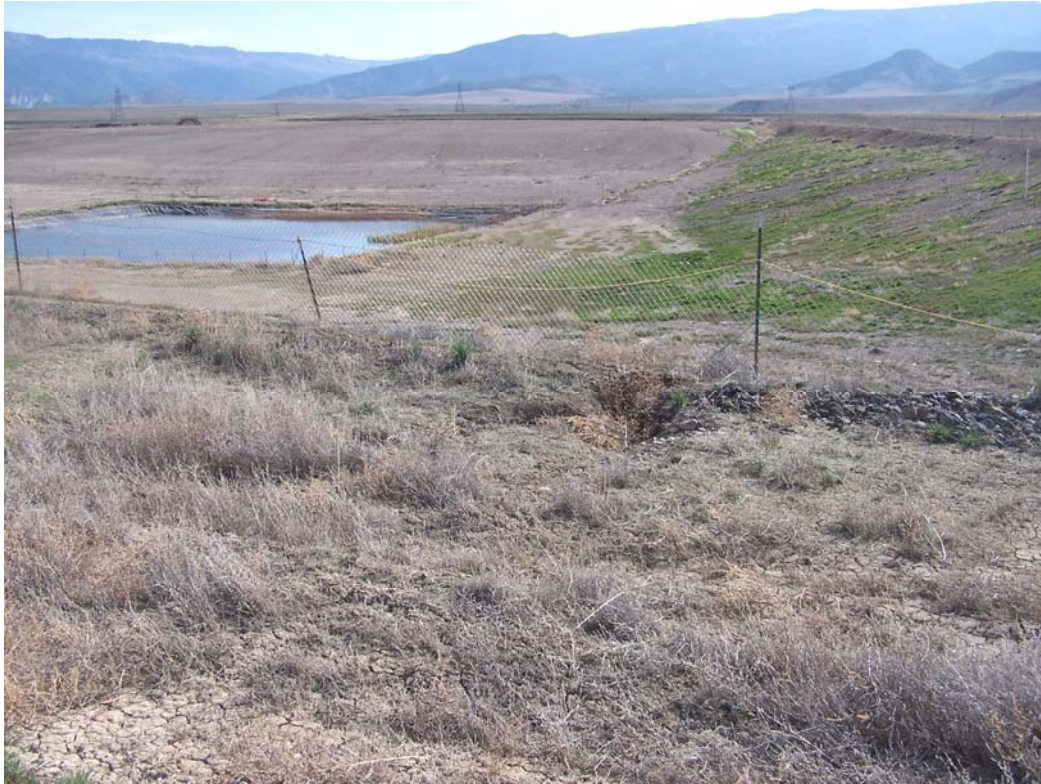
- 6B** A small gully has formed on the disposal cell cover that drains and is mobilizing a minor amount of sediment onto the southwest slope of the open cell area (PL-3). This location was repaired to prevent further erosion into the open portion of the cell.

GRJ 4/2007. PL-3. Gully at the southwest corner of the open cell area.

- The gully on the southwest slope of the open portion of the cell was repaired to prevent further erosion.

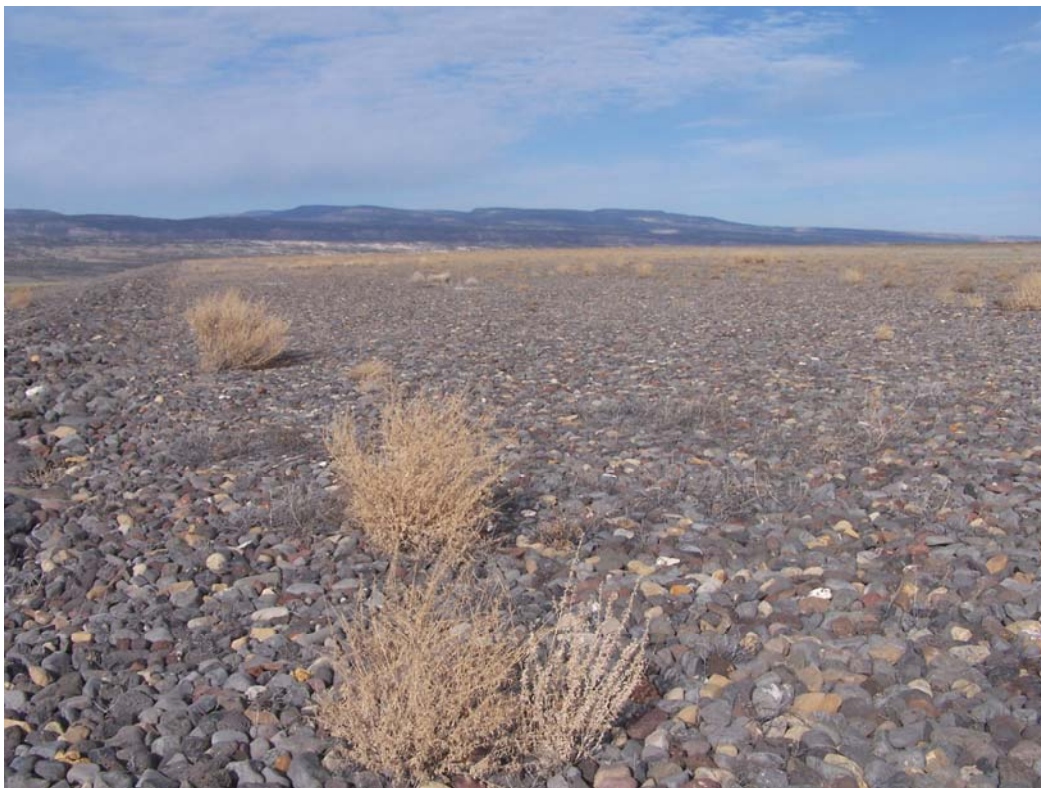
Grasses and weeds grow on most of the cell cover, and scattered deep-rooted vegetation (primarily shrubs) has been persistent on the cover (PL-4). Deep-rooted vegetation was sprayed with herbicide in 2006, and the dead vegetation was evident. Some shrubs have started to grow back and their locations were noted during this inspection. Control of deep-rooted vegetation on the disposal cell continues.

GRJ 4/2007. PL-4. Deep-rooted vegetation on the southeast portion of the disposal cell cover.

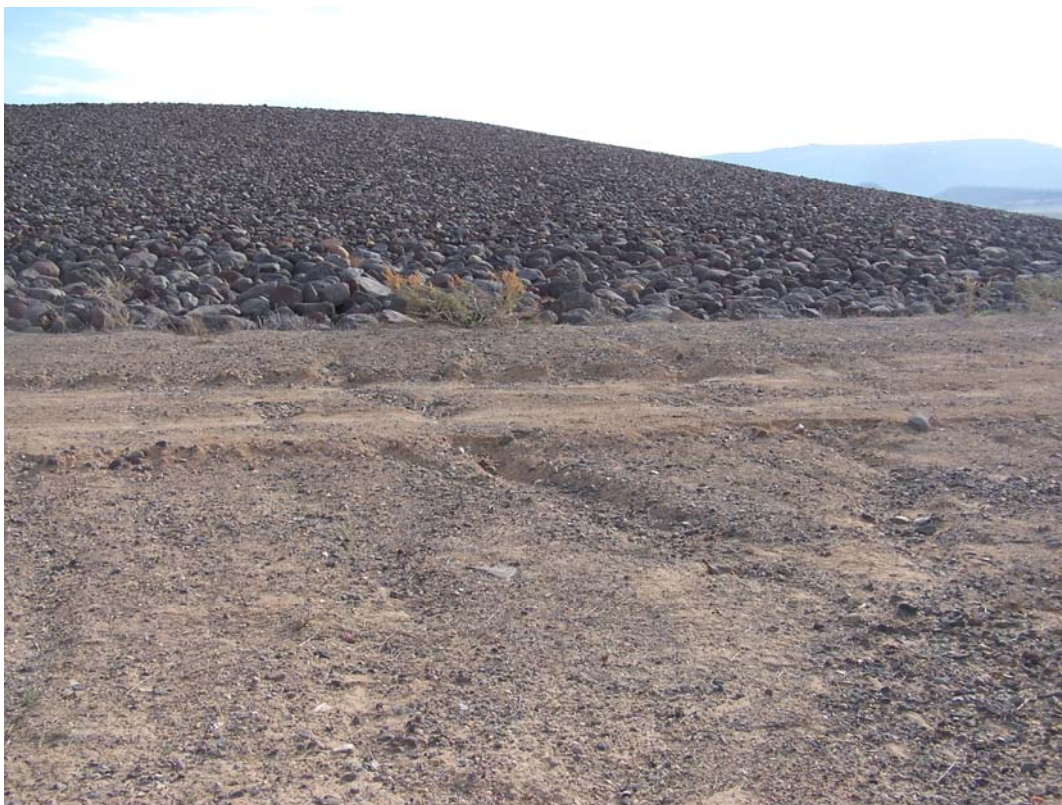
Severe rainstorm events during fall 2006 apparently caused the cell apron (a rock-filled trench) to overflow at the southwest corner of the disposal cell. Several small rills developed across the apron perimeter road (PL-5), but are insignificant and do not require repair at this time.

GRJ 4/2007. PL-5. Rills at the southwest corner of the disposal cell.

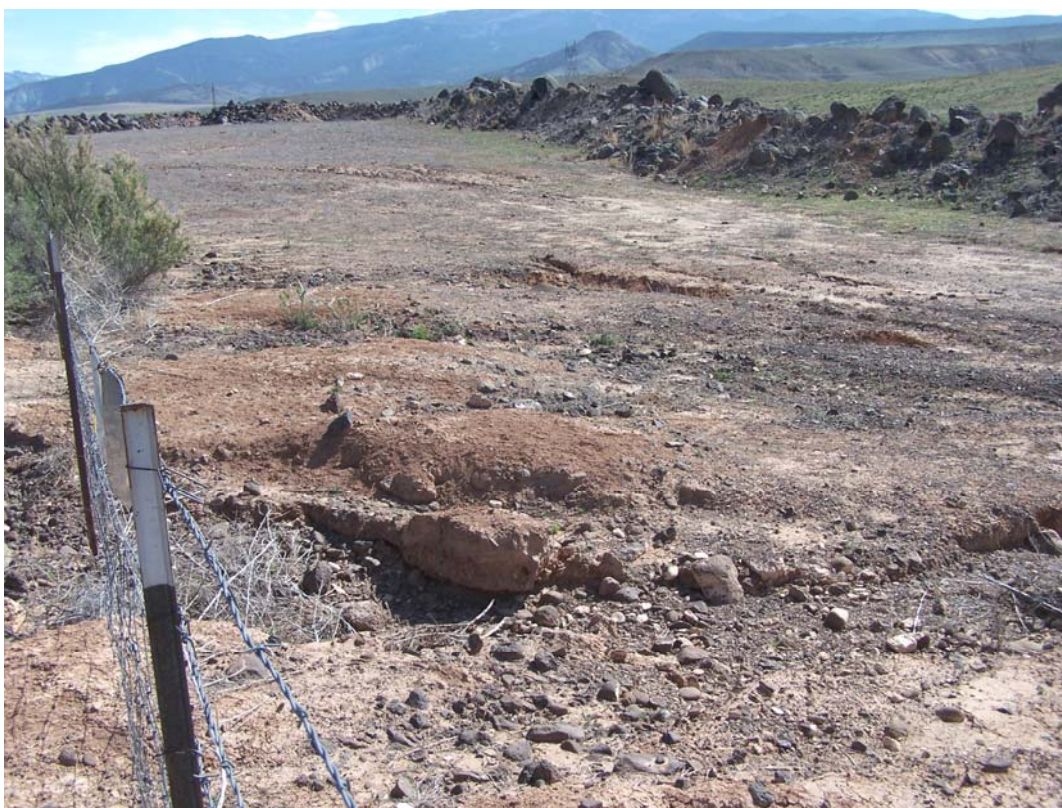
Diversion Structures and Drainage Channels—The south diversion channel is a large riprap-armored structure that conveys runoff water from the disposal cell southeast into a natural drainage that flows away from the site to the southwest. The diversion channel is in excellent condition. Some plant growth, including grasses, weeds and deep-rooted shrubs, exists within the channel. However, there is not enough growth to impede water flow within the channel. Erosional features at the outfall of the channel are self-armoring with large riprap boulders and are stable. An area of active erosion was noted east of the outfall area (PL-6), but no surveillance features are threatened and the area is expected to stabilize.

GRJ 4/2007. PL-6. Rills and gullies east of the south diversion channel outfall.

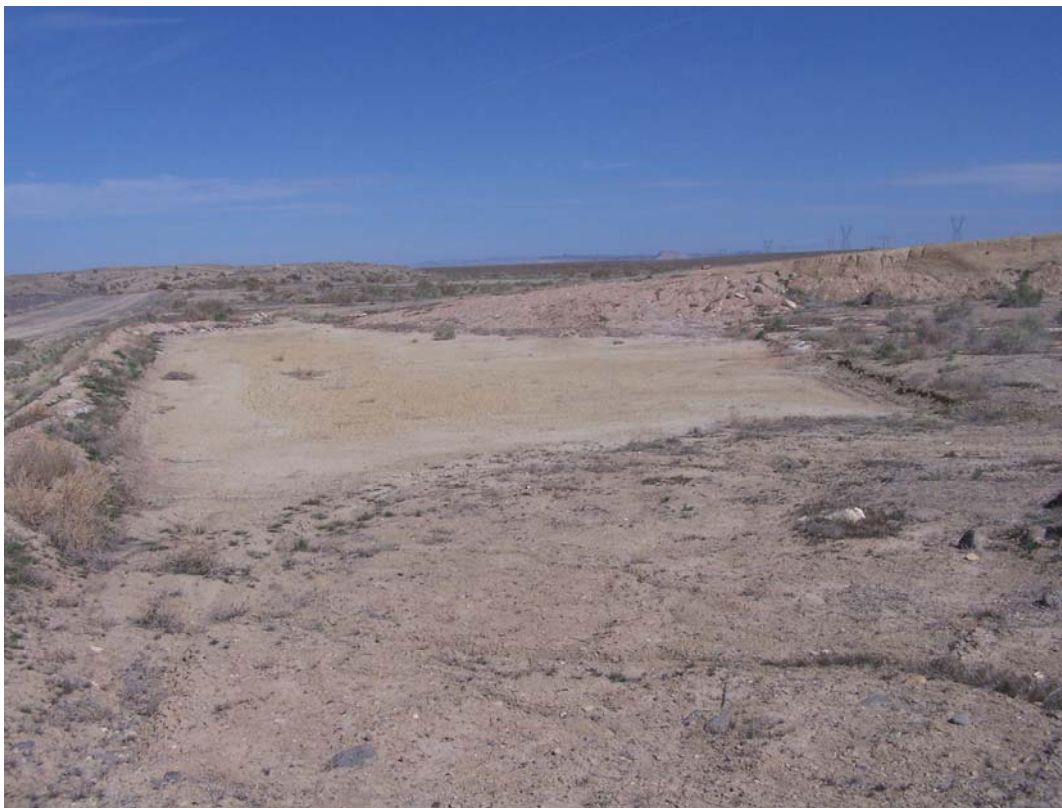
6D Other drainage features at the site include north and south storm water collection ditches, the north storm water retention pond, and a storm water and sediment collection pond on the east side of the south diversion channel. These small drainage features control storm water runoff primarily from the various cover materials stockpiled on the northern and eastern portions of the disposal site property. The north storm water collection ditch also captures run-on storm water from a large catchment area north and east of the disposal site. The drainage ditches and the north storm water retention pond are functioning as designed. The east storm water collection pond (PL-7) was deepened to control runoff leaks onto the adjacent access road; the material removed was used to align the edge of the south storm water collection ditch. Additional maintenance may be needed in the future to retain the ponded water.

GRJ 4/2007. PL-7. Storm water and sediment collection pond adjacent to the south diversion channel.

- The storm water and sediment collection pond on the eastern side of the diversion channel was deepened and the material used to align the edge of the south storm water collection ditch in order to prevent runoff onto the access road.
- Tamarisk was cut and treated with herbicide.
- Perimeter sign P17 was replaced.
